## MOTOR BOAT PRE PURCHASE

| DATE OF INSPECTION: | 08 January 2025 |
| SITE: | D'Albora Marina, Spit Bridge Mosman, NSW |
| VESSEL DESIGN: | 2019 Bavaria S36 Coupe |

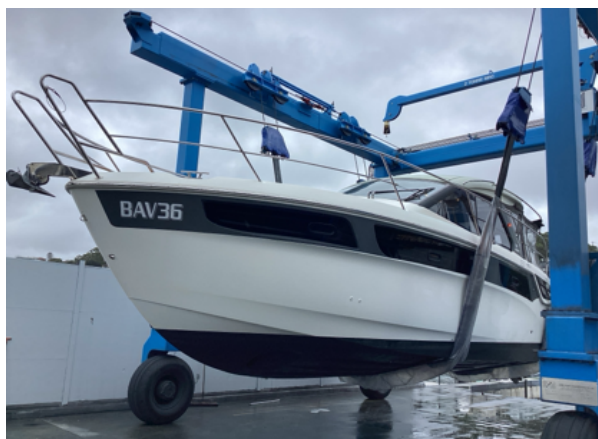
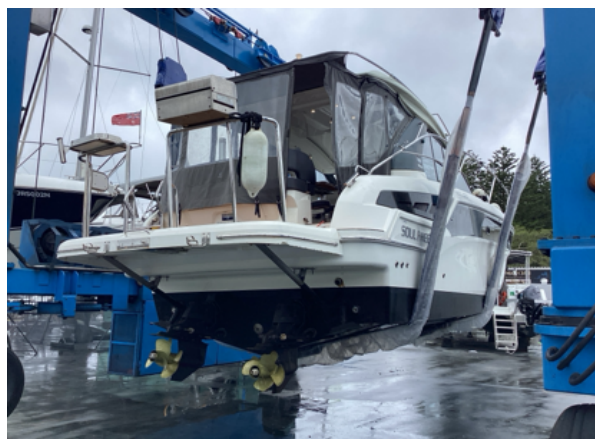
| OTHER: | A couple of very minor gelcoat chips just above the waterline |

1. Some minor gelcoat chips on the lower sides of the hull. Nothing major & could be repaired during the next OOW period.
2. Underwater lights have water in them. Replacement during the next OOW period.

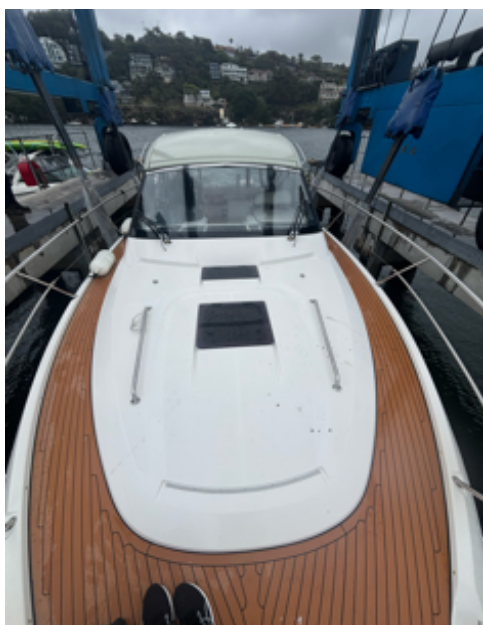
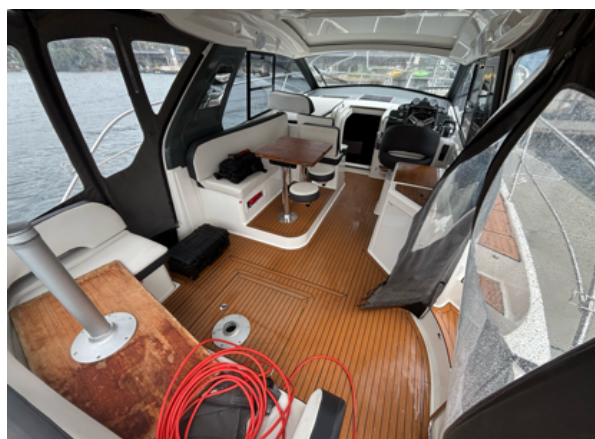
| GRAB RAILS: | Hardtop grab rails are loose. Need to be resealed & tightened |

| SUN ROOF | In good condition with general wear & tear. Service required to stop the squeaking |

5. Forward cabin air con controller is not powering up.
6. Stb side hand rail on the hardtop is loose.
7. Sunroof is squeaky, silicone spray required.
8. Engine bay high level float switch is broken & requires replacing.

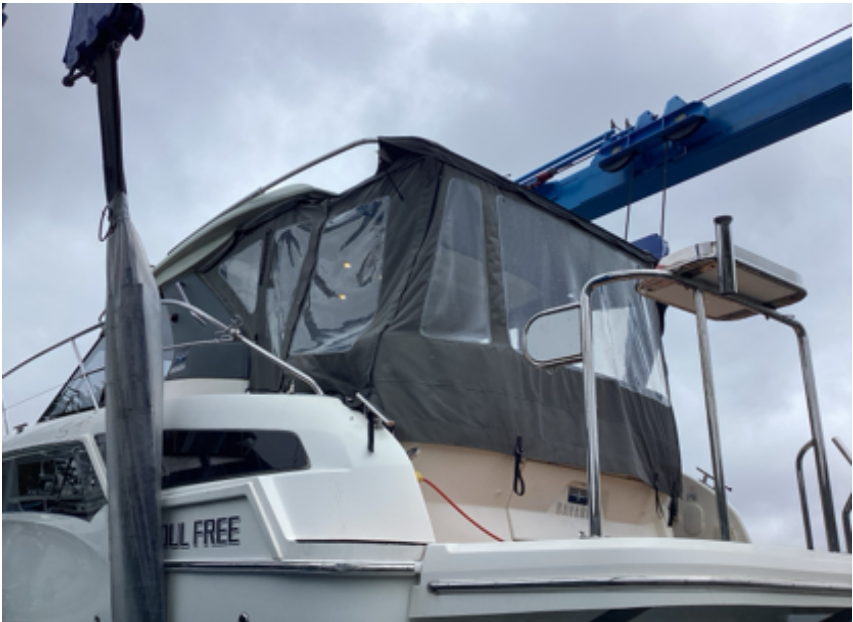
| COCKPIT: | Covers damaged & require replacing |

9. Wiper blades require adjusting & could use some new blade inserts.
10. Rear cockpit covers require replacing.
11. Port stern drive leg trim gauge is not reading, but the leg is going up & down.

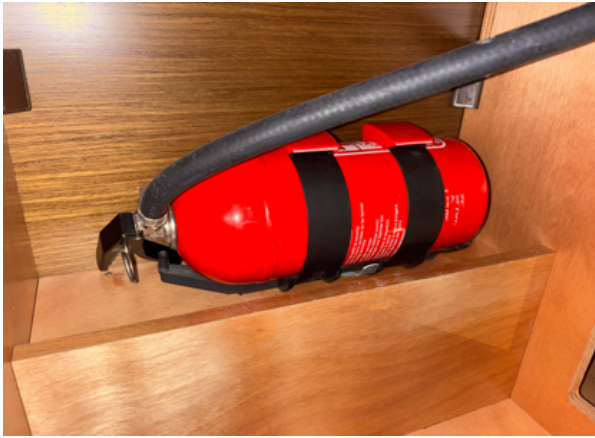
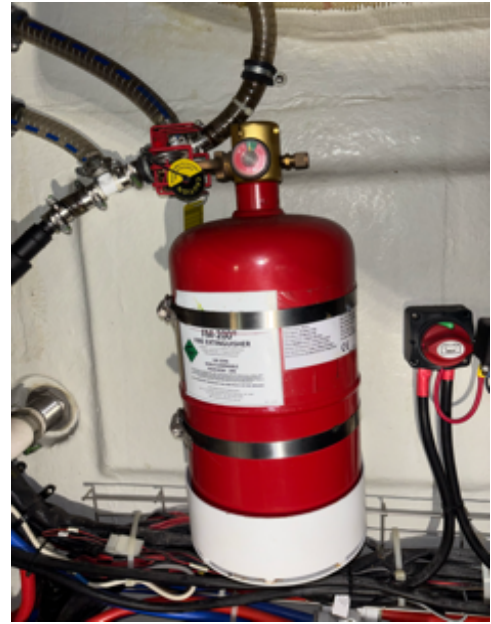
| FIRE BLANKET | Not sighted |
| SMOKE DETECTORS | Not installed |
| SERVICE | No records onboard of the ladt fire system inspection/service |

14. No fire blanket sighted.
15. No first aid kit sighted.
16. Vessel has no cutlery, plating, cups or cooking equipment onboard.
17. Vessels fire fighting equipment should be updated.

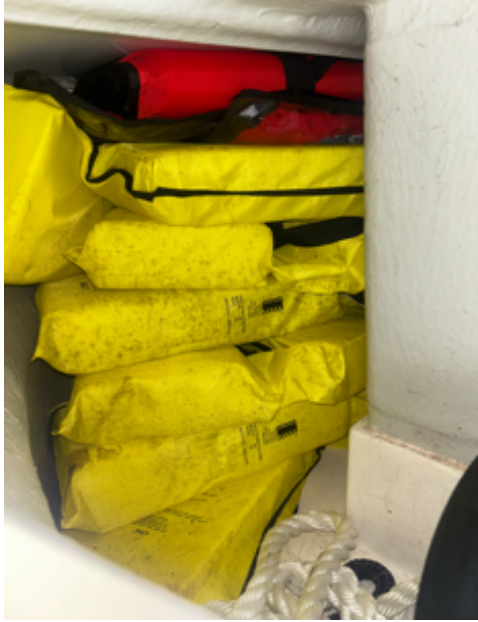
| LIFE JACKETS | Minimal amount located in the rear storage locker |
| FLARES | No flares sighted onboard |
| EPIRB | No EPIRB sighted onboard |
| WATERPROOF TORCHES | No torches sighted onboard |
| FIRST AID KIT | No first aid kit sighted onboard |

18. Vessels life saving equipment should be updated.
19. If travelling outside the safety of a harbour, then an EPIRB should be registered & stored onboard the vessel.
